Crankshaft Failure and Why It May Happen Again

D.A. Moore, K.F. Packer, A.J. Jones, and D.M. Carlson

This case study involves two continuously cast steel crankshaft failures. Three parties performed their own failure analyses: (1) the engine manufacturer responsible for component design, specification, and application; (2) the steel supplier and forging supplier responsible for making the steel, forging the shape, and preliminary heat treatment; and (3) a supplier that provided induction hardening, finish machining, and inspection. An independent fourth party engineering firm was subsequently involved, but because each party had their own agenda, there was no agreement on the metallurgical failure cause and therefore no continued analysis to pin-down and eliminate the root cause. A classic case showing how we may be doomed to repeat our failures because sound engineering was not allowed to proceed.

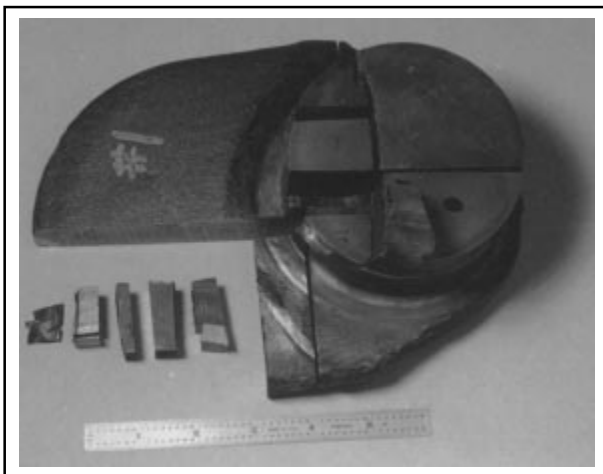
Fig. 1 Sectioned #2 pin journal from Crank #1

Crank #1 exhibited cracking on the journal surface that is longitudinally oriented near the middle of the surface, becoming diagonal and then circumferential near each end of the journal. Circumferential abrasive wear patterns were present over the entire journal surface, with more severe areas located along the center and near an area of spalling along the cracks (Fig. 3). Several areas on the surface exhibited small, longitudinally oriented heat check cracks, particularly aligned with the wear near the area of spalling.

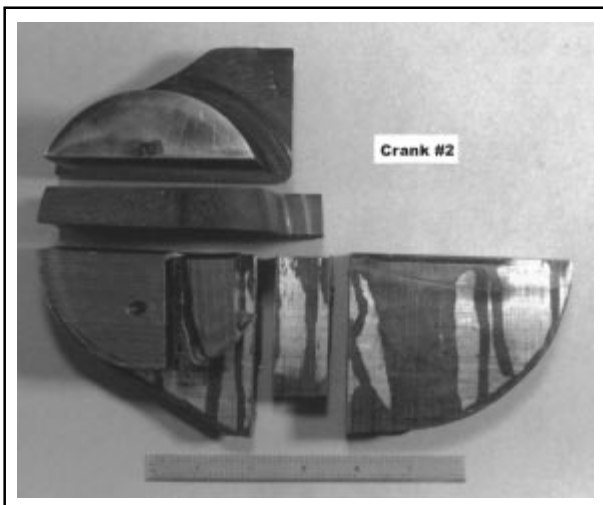
Fig. 2 Sectioned #2 pin journal from Crank #2

Crank #2 exhibited similar cracking patterns, although the cracking had not progressed as extensively around the pin journal circumference. The degree of abrasive wear was somewhat less than that observed on crank #1. A small amount of chipping was observed along the crack edges, but no large spalled area was observed as found on crank #1.

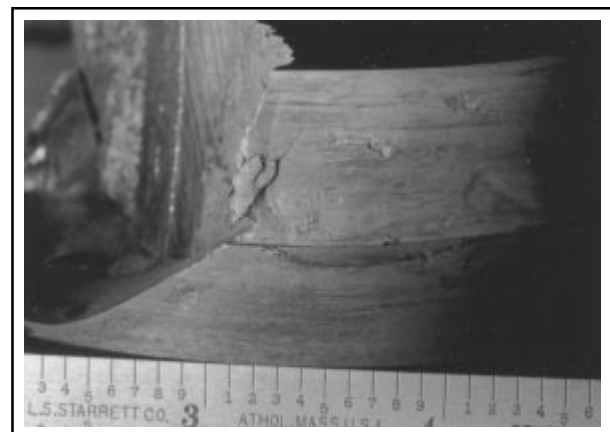
Fig. 3 Severe wear and spalling near the center journal surface on Crank #1

At the location of spalling in crank #1, a high concentration of MnS inclusions and some oxides were observed just beneath the surface of the journal.

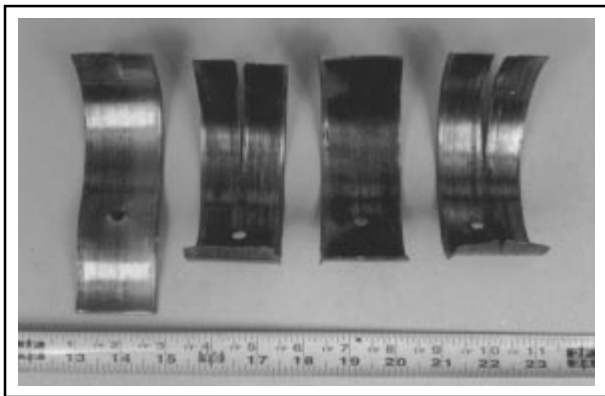
Examination of the connecting rod bearings from crank #1, pin #2 showed that substantial abrasive wear and heat had affected the bearings causing them to mushroom, craze crack, and generally deteriorate. Abrasive wear was present on both sides indicating the bearings were spinning within the connecting rod end. In one set of bearings, a very deep groove was worn through part of the bearing presumably from a trapped piece(s) of the fractured pin journal (Fig. 4 and 5).

Fig. 4 Connecting rod bearings from Crank #1, pin #2

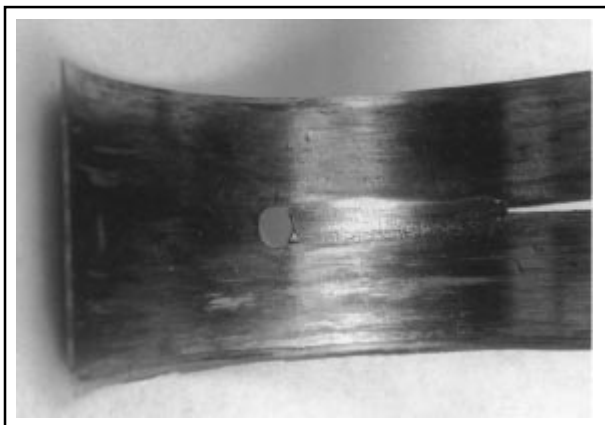
Substantial bearing wear and damage was also observed in the connecting rod bearings from pin #2 on crank #2. These bearings also appeared to have been spinning within the connecting rod end. The remaining bearings from crank #2 were in good condition with no signs of poor lubrication or spinning within the connecting rods.

Fig. 5 Connecting rod bearing from Crank #2, pin #2

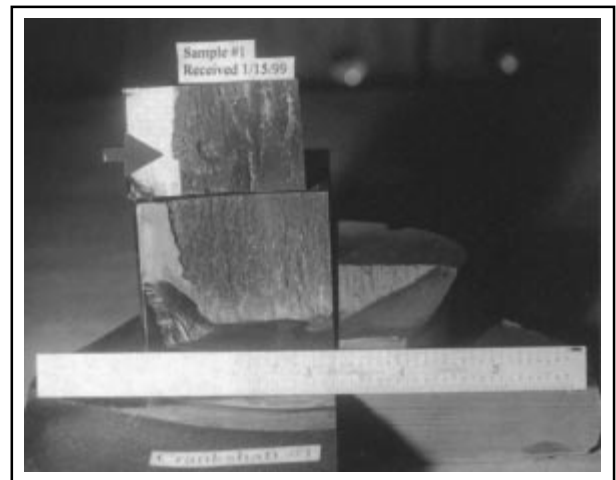
Both #2 pins exhibited large, woody textured fracture planes oriented perpendicular to the plane between 12 and 6 o'clock on the pin (Fig. 6 and 7).

This fracture plane is about 2 1/2 in. from the 12 o'clock position. Near the center of this woody plane, the fracture has a smoother and flatter appearance. Oblique lighting on the woody fracture area from crank #1 shows patterns in this smooth region indicating progression outward (Fig. 8). Woody texture is present along this plane, but does not progress out through the induction hardened layer to the surface. Crank #2 exhibits similar features though less obvious due to surface oxidation.

Fig. 6 Woody textured fracture on Crank #1, pin #2

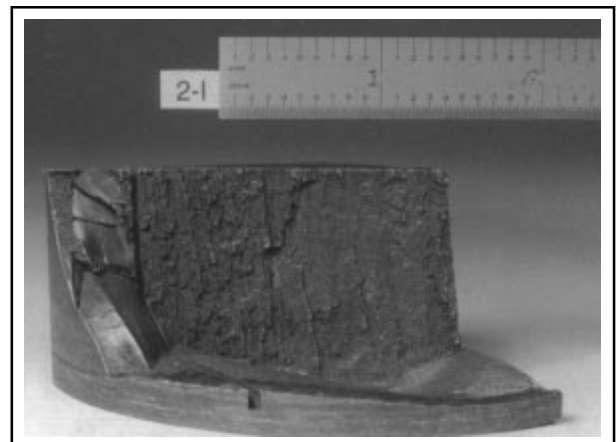
Fig. 7 Woody textured fracture on Crank #2, pin #2

The woody textured fracture was covered with a black substance that prohibited identification of any fine fracture features. Some areas of woody textured fracture were damaged by cleaning and/or etching, so high magnification examination was unsuccessful. EDS analysis of areas on the woody fracture revealed the black layer contained many elements commonly found in oil additives (S, Zn, Ca, Si, P, Mg), so it was presumed that most of the black substance was oil residue.

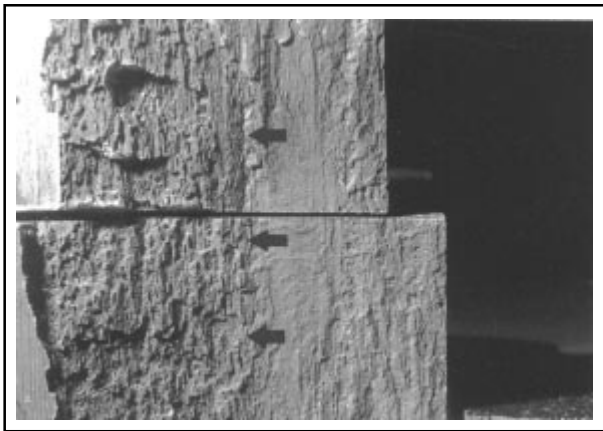
Fig. 8 Woody textured fracture on Crank #1

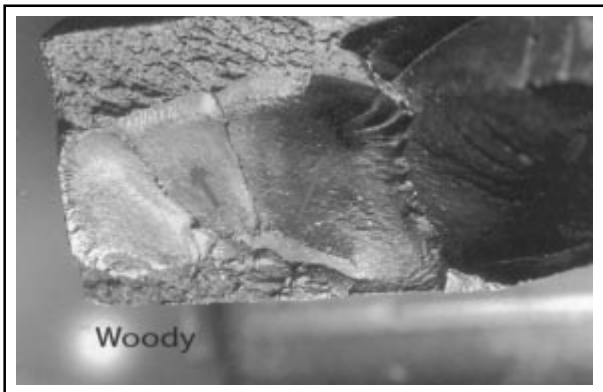
At the edges of the woody textured fracture plane, fatigue fracture planes were observed with striations and river patterns that indicated progression outwards to the journal surface (Fig. 9).

Fig. 9 Fatigue crack progression outwards from the woody texture of fracture towards the journal surface

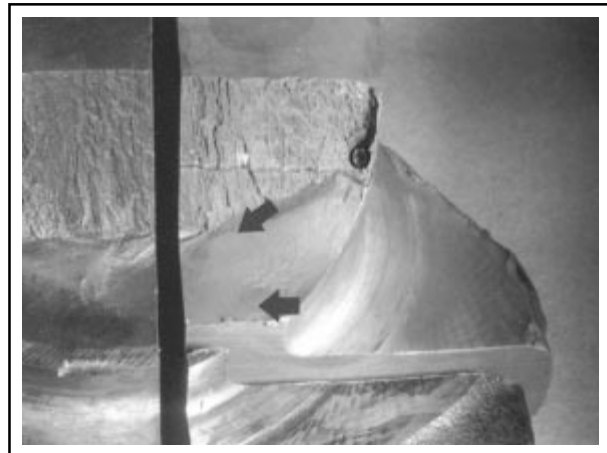
Additionally, larger fatigue fracture surfaces were observed that originated from the edge of the woody textured region and propagated diagonally and circumferentially through the journal (Fig. 10 and 11). River patterns and beach markings on these larger fatigue fracture surfaces indicate that the crack front was altered by intersection with the induction hard-

Fig. 10 Diagonal/circumferential fatigue fracture adjacent to the woody textured fracture

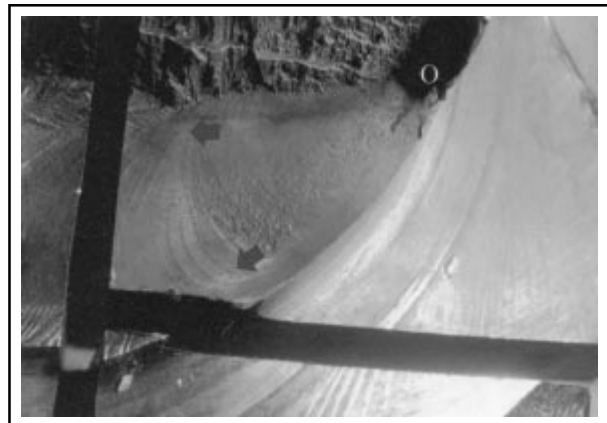
Fig. 11 Diagonal/circumferential fatigue fracture adjacent to the woody textured fracture

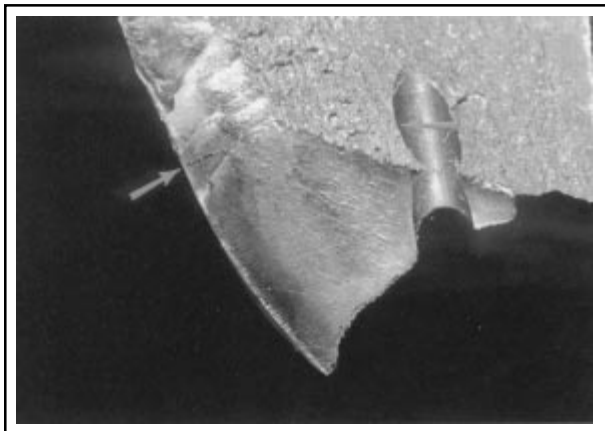
Careful examination of the oil hole present in crank #2 showed that longitudinal tool markings were present, some of which were altered at their intersection with the woody textured fracture plane (Fig. 12 and 13), suggesting the woody fracture was present when the hole was made. A similar area in crank #1 was not observed because that section of the woody textured fracture was not provided.

Fig. 12 Fatigue crack that intersected the woody fracture

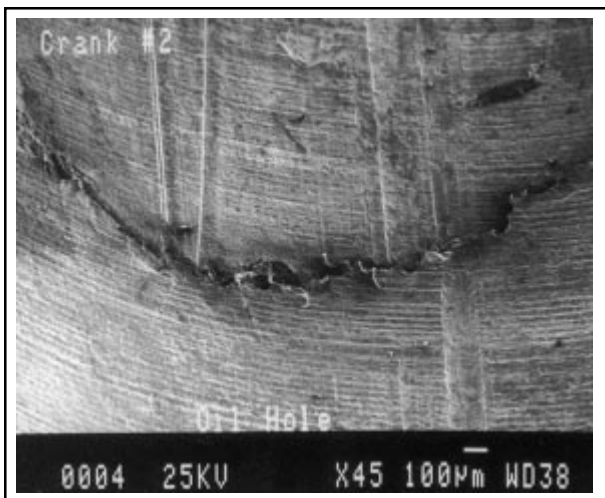
Fig. 13 A drilled hole with tool marking that was altered by the woody textured fracture plane

3. The woody fracture pre-existed final machining and heat treatment, as evidenced by the disruption of tool withdrawal markings in the oil hole on crank #2. (A similar determination was not possible on crank #1 because the material containing the oil hole and woody fracture intersection was not available.)

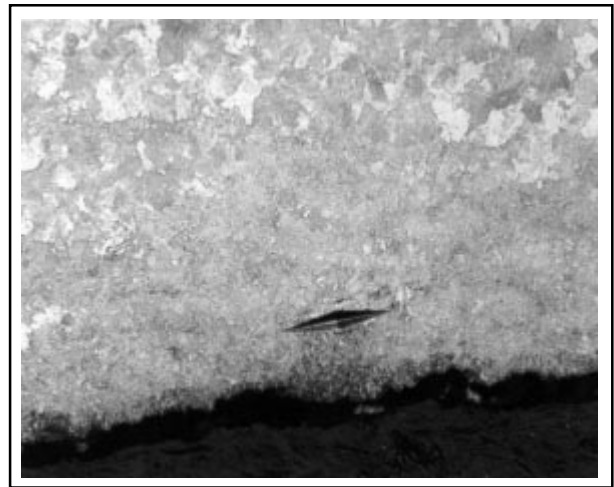
Transverse sections through the #2 pin revealed that the core microstructure was primarily pearlite and ferrite, except along the central, smoother portion of the woody textured fracture region. In this area, bands of fine tempered martensite were observed surrounding a higher concentration of MnS inclusions and stringers (Fig. 14). Microhardness measurements confirmed that these microstructural

bands exhibited higher hardness (as high as 37 HRC) than the surrounding core (20 to 30 HRC).

Fig. 14 A band of martensite found at the woody textured fracture edge

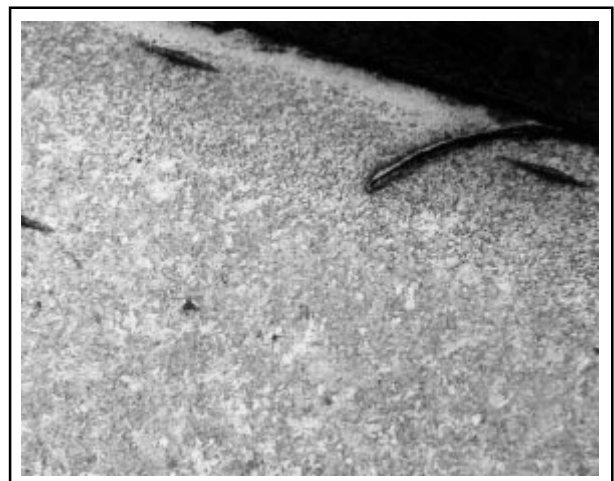
Fig. 16 Cracking, deformation, and a white hardened layer at the journal surface of Crank #1

At various locations around the journal surface, the induction hardened layer exhibited variations in microstructure. In areas near the spalling on crank #1, cracking, deformation, and a white hardened layer were observed at the journal surface indicating frictional heating (Fig. 16).

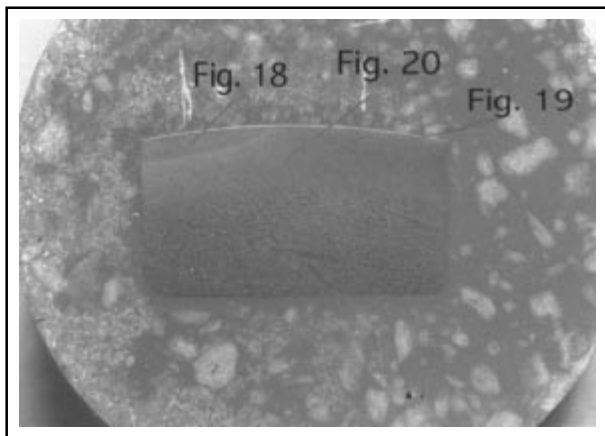
Other areas exhibited similar signs of friction damage, although not as pronounced. The most severely damaged areas exhibited a 1 to 2 mm thick layer of transformed structure at the surface with tempered martensite beneath (Fig. 17, 18, 19, and 20). Hardness measurements reflect the changes in microstructure with the white layer being as hard as 66 HRC, and the layers beneath having hardness

Fig. 17 Macro view of metallographic cross section through the journal surface

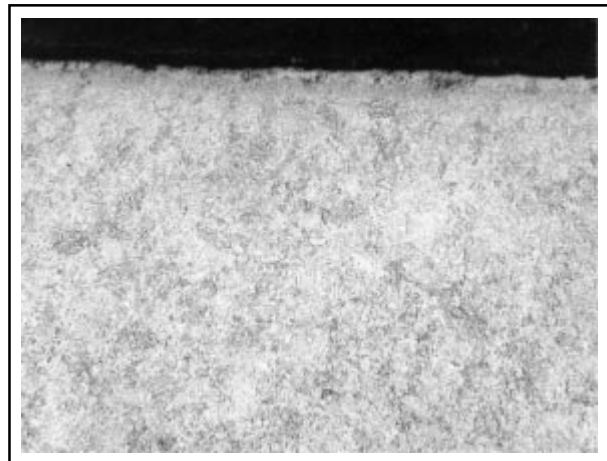
Fig. 19 Surface away from severe friction damage

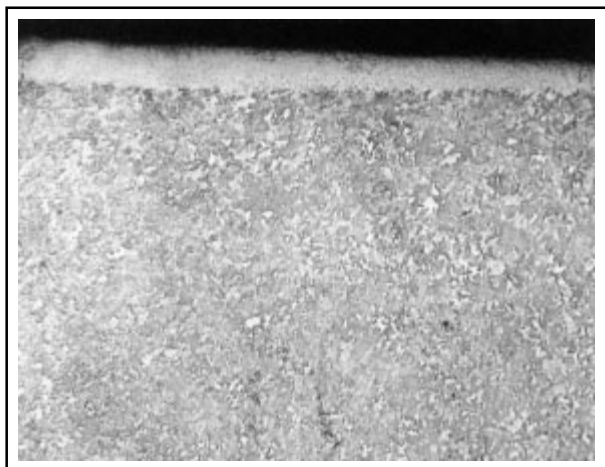
Fig. 18 Frictional heating at surface

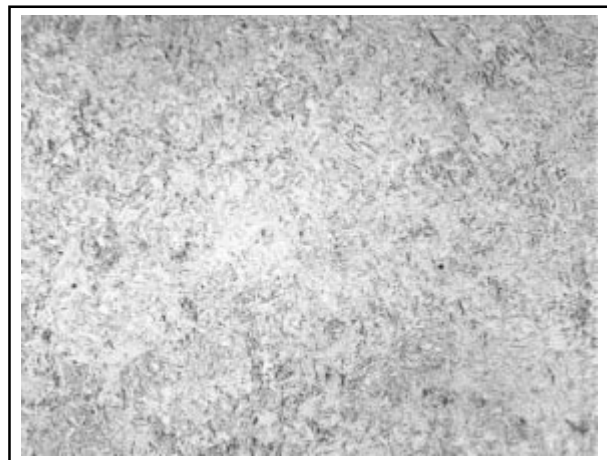
Fig. 20 Microstructure just below surface layer

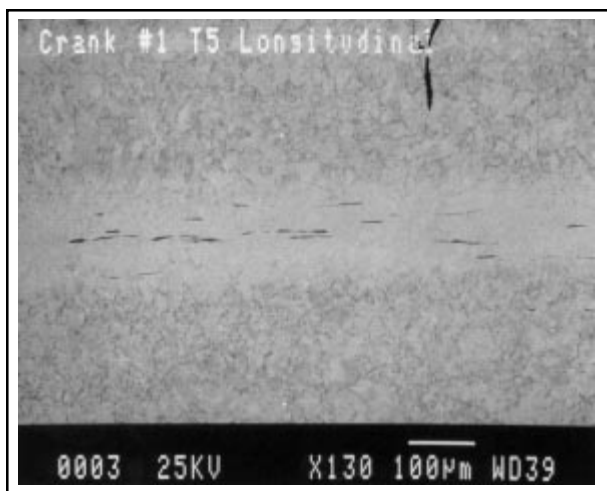
Transverse sections through the #1, #3, and #5 pins from crank #1 revealed that each had uniform, tempered martensite induction layers with hardness of about 50 HRC at the surface. The core microstructures were primarily ferrite and pearlite, but bands of tempered martensite and MnS inclusions were observed similar to that observed in fractured #2 pins (Fig. 21). The location of this microstructural feature was near the surface in pin #1, and nearer the center of the core in pin #5 (Fig. 22). Similar to the bands in crank #2, the bands found in other pins also exhibited higher hardness than the surrounding core.

Fig. 21 SEM backscatter electron image of MnS inclusions surrounded by tempered martensite in Crank #1, pin #5

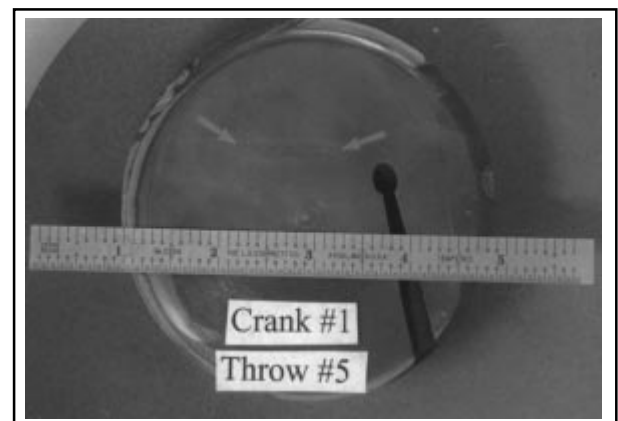
A macro-etched transverse section through crank #1 and crank #2 showed a distinctly recognizable area of non-uniform induction case. The macro-etched pattern is similarly oriented on both cranks, although the effects are more pronounced in crank #1.

Fig. 22 Macro-etched cross section through Crank #1, pin #5
